PMUSB12

Designed for 2012-2014 Ford® Mustang vehicles with base audio systems

Installation

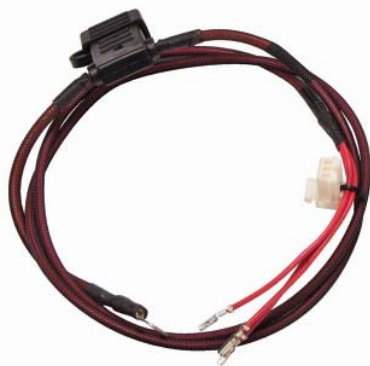
Power Harness

25A Fuse
Wire Ties x6
Star Washer

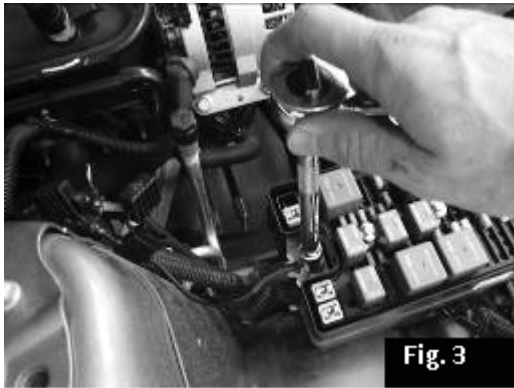
5. Remove the fuse box cover under the hood and remove the nut from the main power lug.
6. Connect both the subwoofer and amplifier power harnesses to the lug and retighten the nut. Torque to 20Nm. Fig. 3

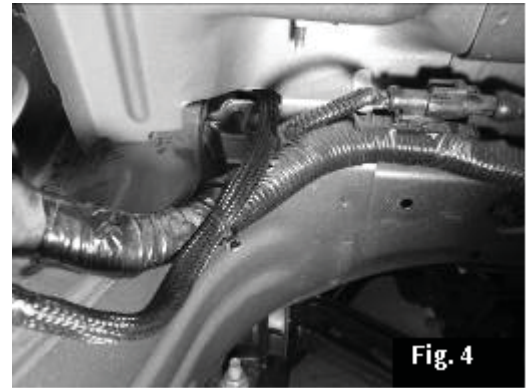
7. Route the power harnesses down to the small opening near the fire wall that leads into the fender well area. Fig. 4

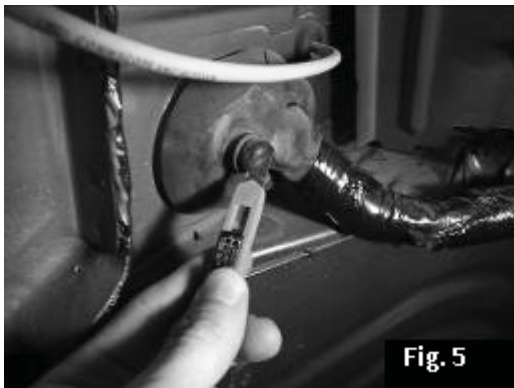
8. Using a razor knife make a small incision in the rubber grommet. Fig. 5

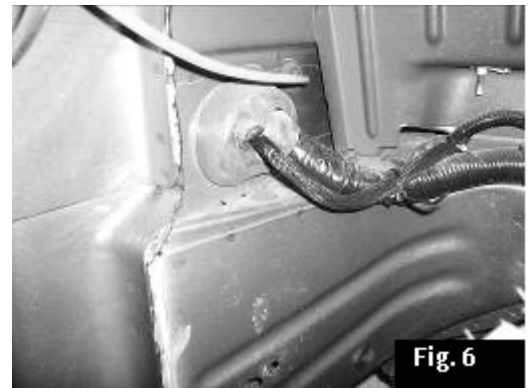
9. Pass the power harnesses into the cabin and secure with the provided wire ties. Fig. 6

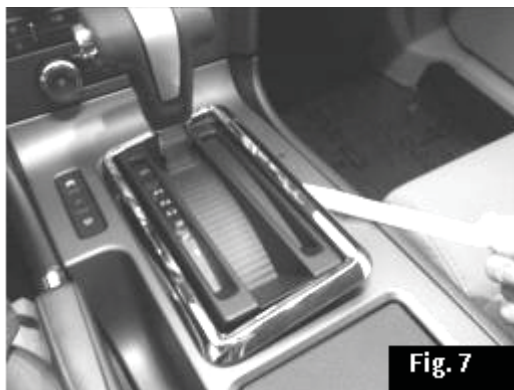
11. Using a panel removal tool gently pry loose the bezel around the shifter and remove. Fig. 7

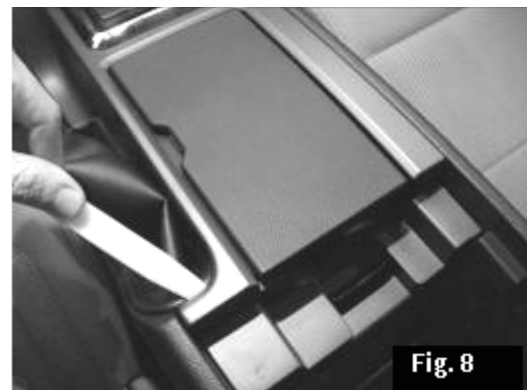
12. Open the center console lid and gently pry loose the top of the console. Disconnect wiring and set aside. Fig. 8

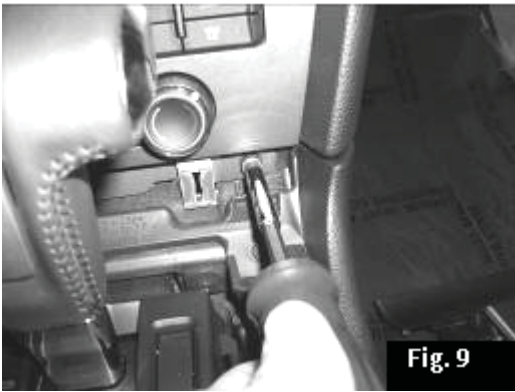
13. Remove the two screws securing the bottom of the radio bezel. Fig. 9

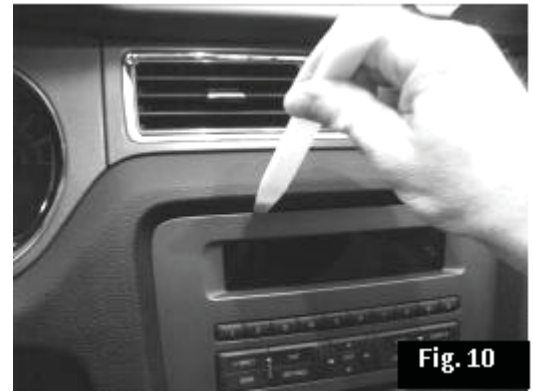
14. Pry loose the radio bezel and disconnect wiring. Fig. 10

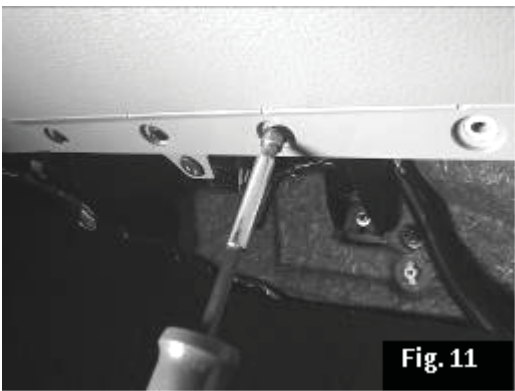
16. Remove the four screws along the bottom of the glove compartment. Fig. 11

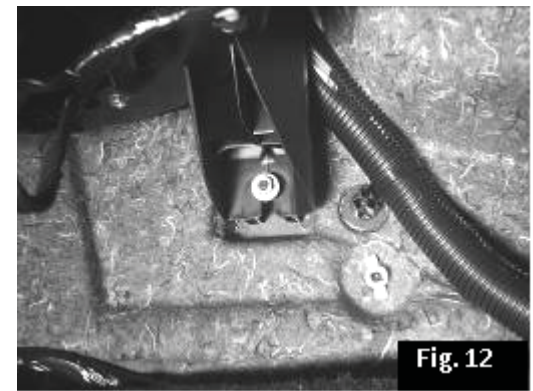
17. Remove the nut from the stud at the base of the HVAC fan housing. Fig. 12

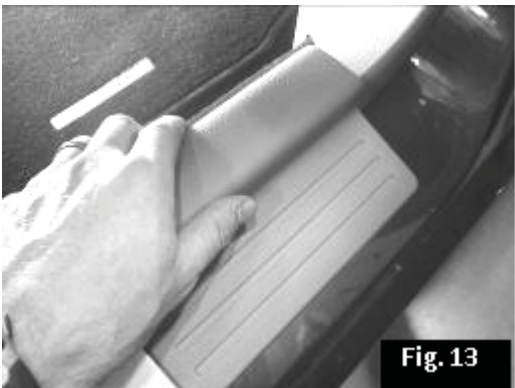
18. Remove the sill plate along the bottom of the passenger's side door opening. Fig. 13

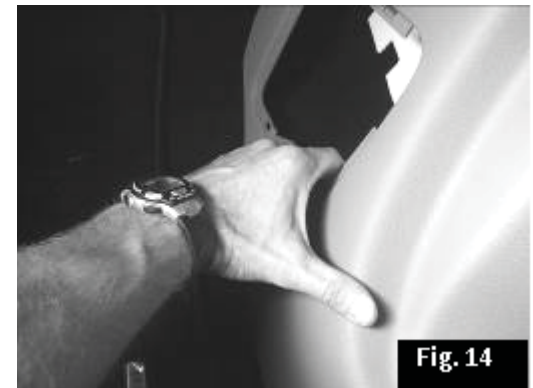
19. Remove the passenger's side kick panel by pulling toward the center of the car and then straight back to release the fasteners. Fig. 14

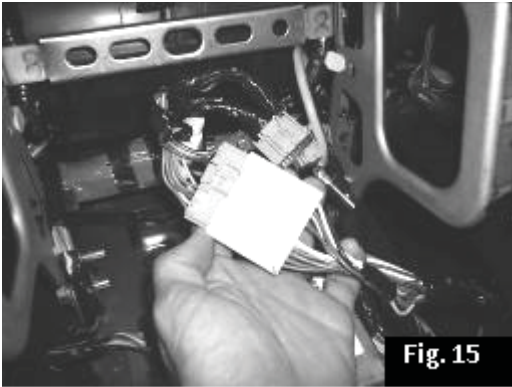
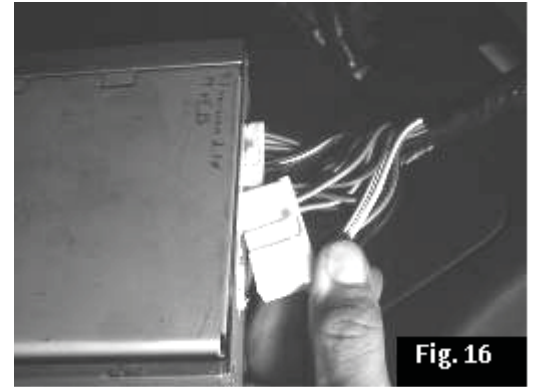
20. Connect the radio connector to the amplifier body harness and tuck the connectors out of the way to avoid interference when reinstalling the radio. Fig. 15

21. Route the other end of the body harness down to the area below the glove compartment and connect it to the amplifier. Fig. 16

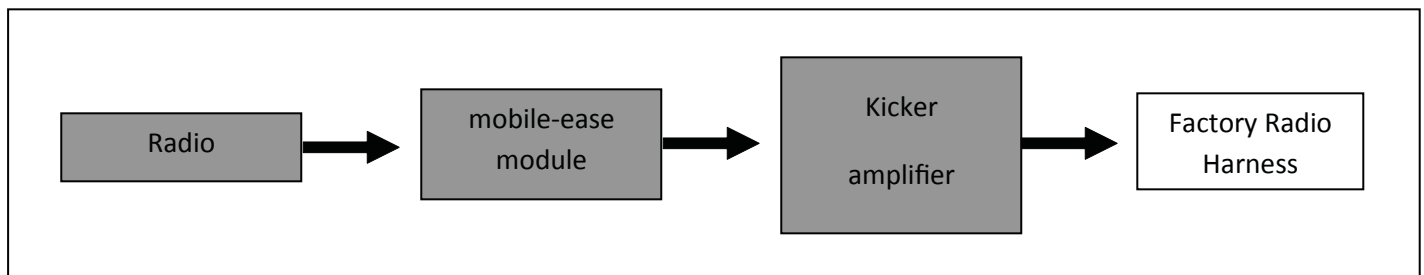
If the vehicle is equipped with Mobile-Ease Bluetooth™ device the wiring must be connected in the following order.

- A. Disconnect the factory wiring from the radio. (Large and Medium sized connectors only)
- B. Connect the two corresponding connectors of the Mobile-Ease harness to the radio.
- C. Connect the Kicker® amplifier body harness to the Mobile-Ease harness.
- D. Connect the remaining connector of the Kicker® amplifier body harness back to the factory wiring.

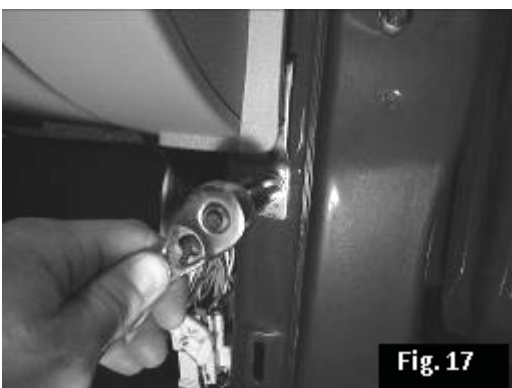
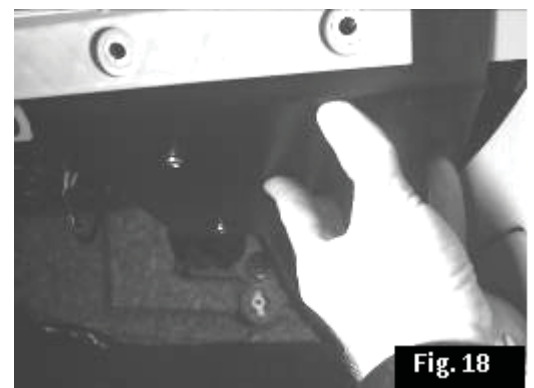
24. Connect the black ground wire of the amplifier harness and the subwoofer harness to the bolt in just below the edge of the dash. Torque to 20Nm. Fig. 17

25. Install the amplifier/bracket assembly over the HVAC blower housing stud and behind the bottom of the glove compartment. Line up the holes in the bracket with the holes in the glove compartment and reinstall the screws, leave loose. Fig. 18

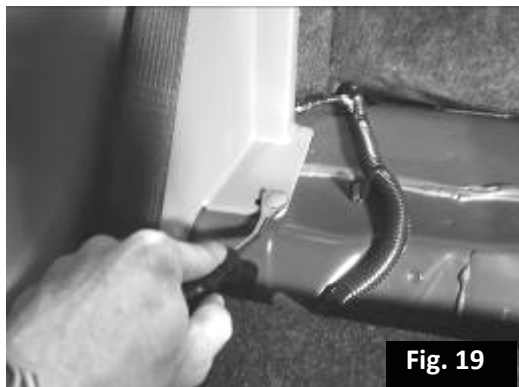
27. Connect the amplifier power harness white three pin connector to the corresponding white three pin connector of the amplifier body harness. Connect the subwoofer power harness black two pin connector to the corresponding black two-pin connector of the subwoofer body harnesses.
28. Remove the lower rear seat cushion by pushing the front edge back and then lifting up.
29. Release and fold down the rear seat backs.
30. Remove the three plastic retainers that secure the quarter panel cover. One retainer is above the floor pan and the other two are located in the pass through area between the cabin and the trunk. Fig. 19
31. Pull the rear quarter panel cover and remove from the car. Fig. 20

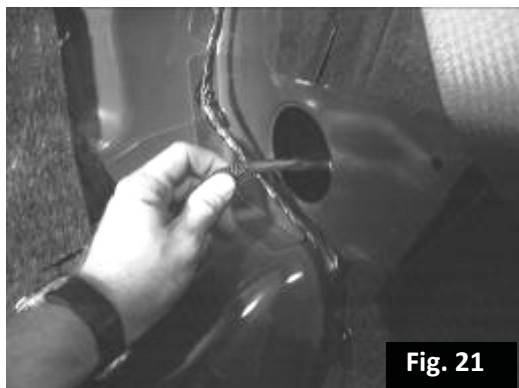
32. Run the body harness along the bottom of the door and secure with wire ties.
33. If the vehicle is equipped with the Shaker 1000 factory subwoofer, disconnect wiring and remove the factory subwoofer.
34. Pass the subwoofer body harness through the round hole in the metal. Fig. 21
35. Make a small "X" shaped cut in the trunk carpet to allow the harness to pass through. Fig. 22

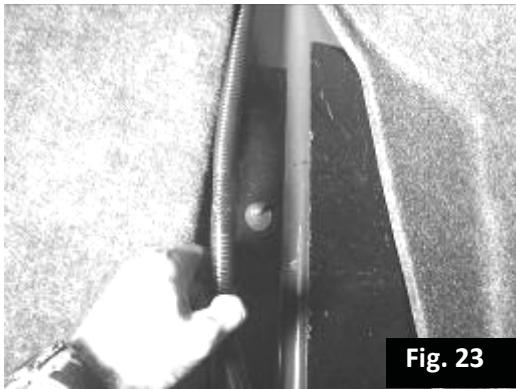
36. Fold back the carpeted trunk liner on the passenger side of the vehicle.
37. Pull the factory wire harness loose from the metal stud where the subwoofer will mount. Fig. 23
38. Remove the bolt near the passenger's side rear tail light.
39. Connect the subwoofer harness to the subwoofer and line the hole in the bottom bracket up with the factory stud in the bottom of the trunk.
40. Slowly rotate the subwoofer into place. Line up the top bracket with the hole near the tail light and reinstall and tighten the bolt. Fig. 24

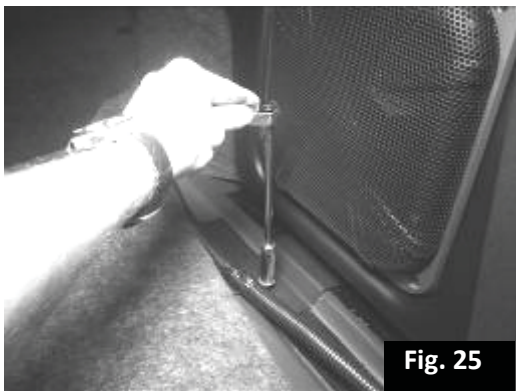
41. Push the subwoofer toward the outside of the car as far as possible and install the supplied 10mm nut on the factory stud and tighten. Fig. 25

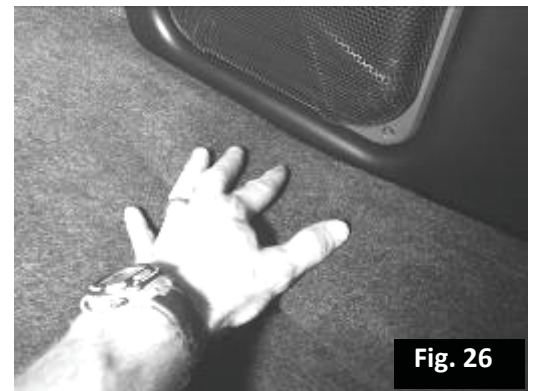
42. Fold about six inches of the trunk liner underneath itself and then tuck the fold under the edge of the subwoofer. Fig. 26
